This factsheet was prepared for the Prehistoric Society by Ian Armit (University of Bradford)

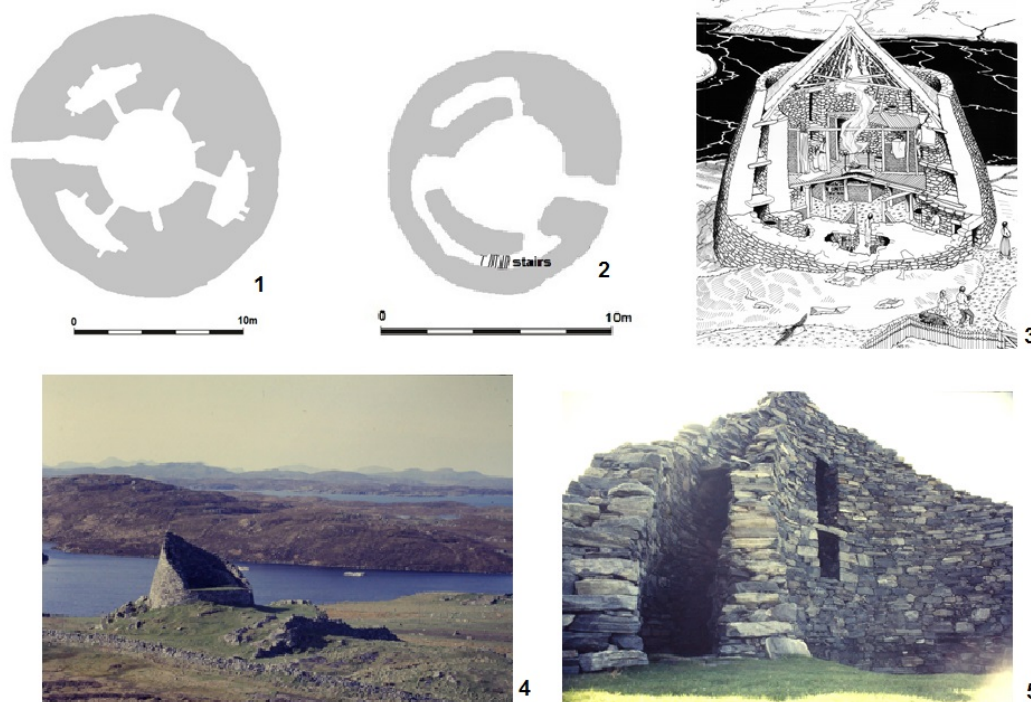
1: - Ground Plan of the Broch of Mousa, Shetland. 2: - Ground plan of Dun Bharabhat, Lewis
 3: - Reconstruction drawing of Dun Carloway. Courtesy & copyright Alan Braby. 4: - View of Dun Carloway, Lweis
 Courtesy & copyright Alex Gibson. 5: - Detail of the cavity wall at Dun Carloway. Courtesy & copyright Alex
 Gibson.

Other architectural elaborations tell us something about the vanished timber components of these buildings. Ledges, called scarcements, projecting from the inner wall, would have supported upper timber floors and rafters for the roof. Vertical rows of small openings, known as wall-voids, were probably

intended to allow air from the internal hearths to circulate, to keep the intra-mural space dry. Although this space was accessible via stairs and galleries in the lower part of the building, as the galleries rose they became too narrow for even the smallest child to squeeze through. Only at Mousa was there access all the way to the wall-head, and it is likely that this is due to reconstruction in the Viking period that turned the old roundhouse into a makeshift fort. Although the roofs of these buildings have long since disappeared, they were most probably of conical thatched construction, like contemporary timber roundhouses in other parts of Britain.
